Reedie Drive Pedestrian Road Safety Audit Montgomery County, Maryland

Prepared For:
Department of Transportation
Montgomery County, Maryland

Prepared By:
Vanasse Hangen Brustlin, Inc.
Silver Spring, Maryland

May 2011

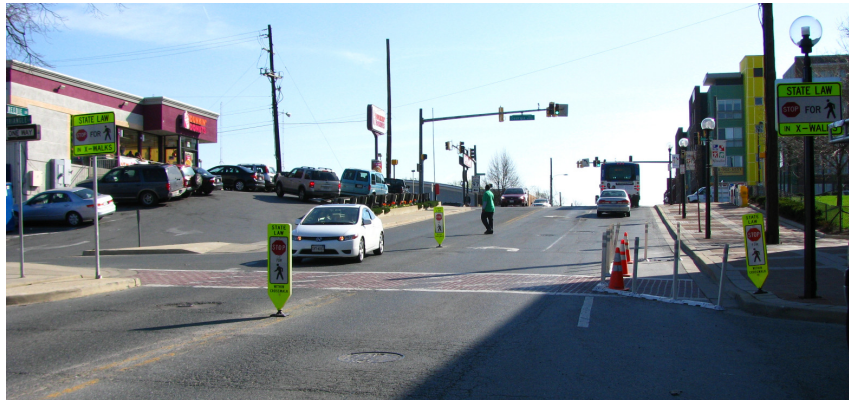
Decorative Crosswalk on Reedie Drive at Triangle Lane

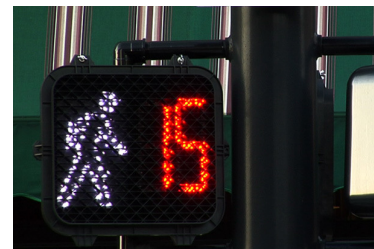
Photo of a countdown signal
